Manhole Inspection Summary

Manhole # S07YY1021MH

Insp Date: **9/15/06 12:42 PM**

Location Address: **5710 woodcrest ave**

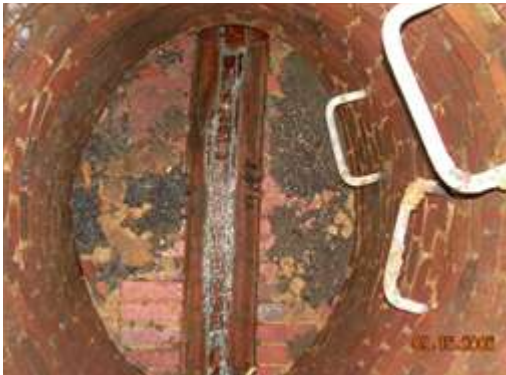
Top View

Condition: ☐ Sound ☐ Cracked ☐ Root Intrusion ☒ **Loose Brick** ☐ Deteriorated

Infiltration: ☐ None ☒ **Joint** ☐ Cracks ☐ Mortar ☐ Roots ☐ Wall

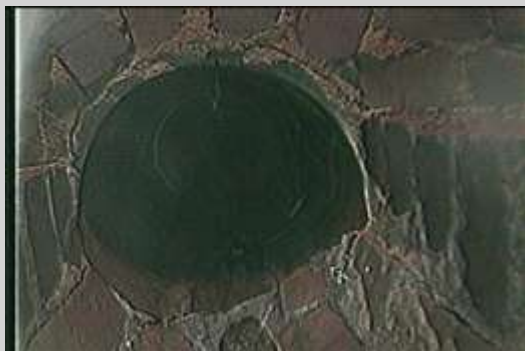
10 in. Circular Gravity Sewer Pipe In @ 6 O'Clock

Infiltration: **None** Pipe Seal Cond: **Unknown**
